The Rail Safety
Inspection Office

NIB ANNUAL REPORT 2022

according to Article 24(3) of Directive (EU) 2016/798

September 2023

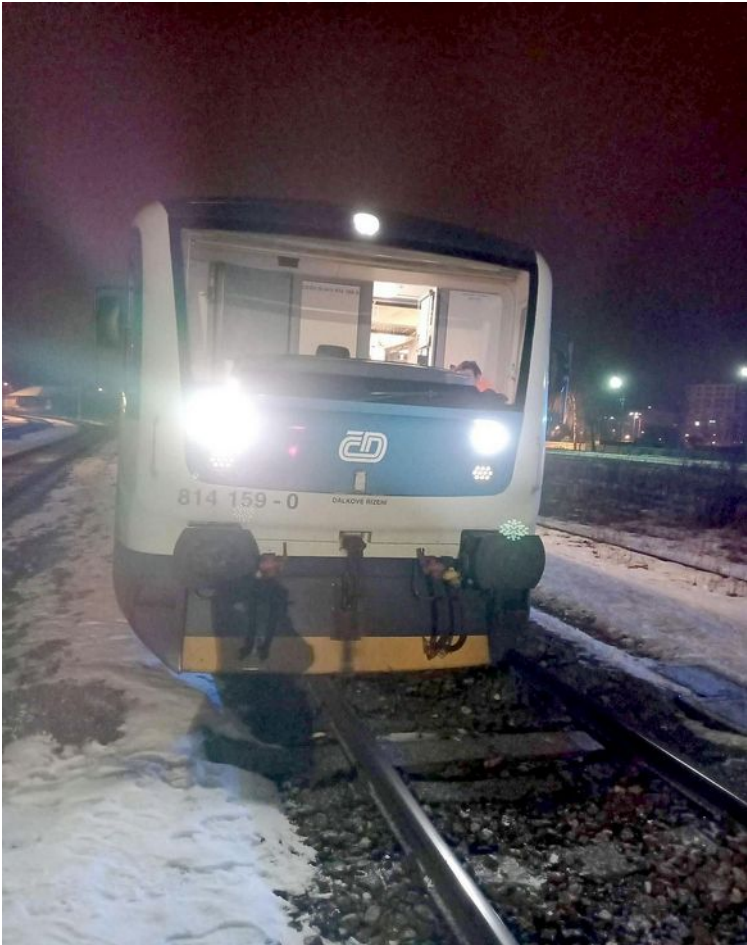
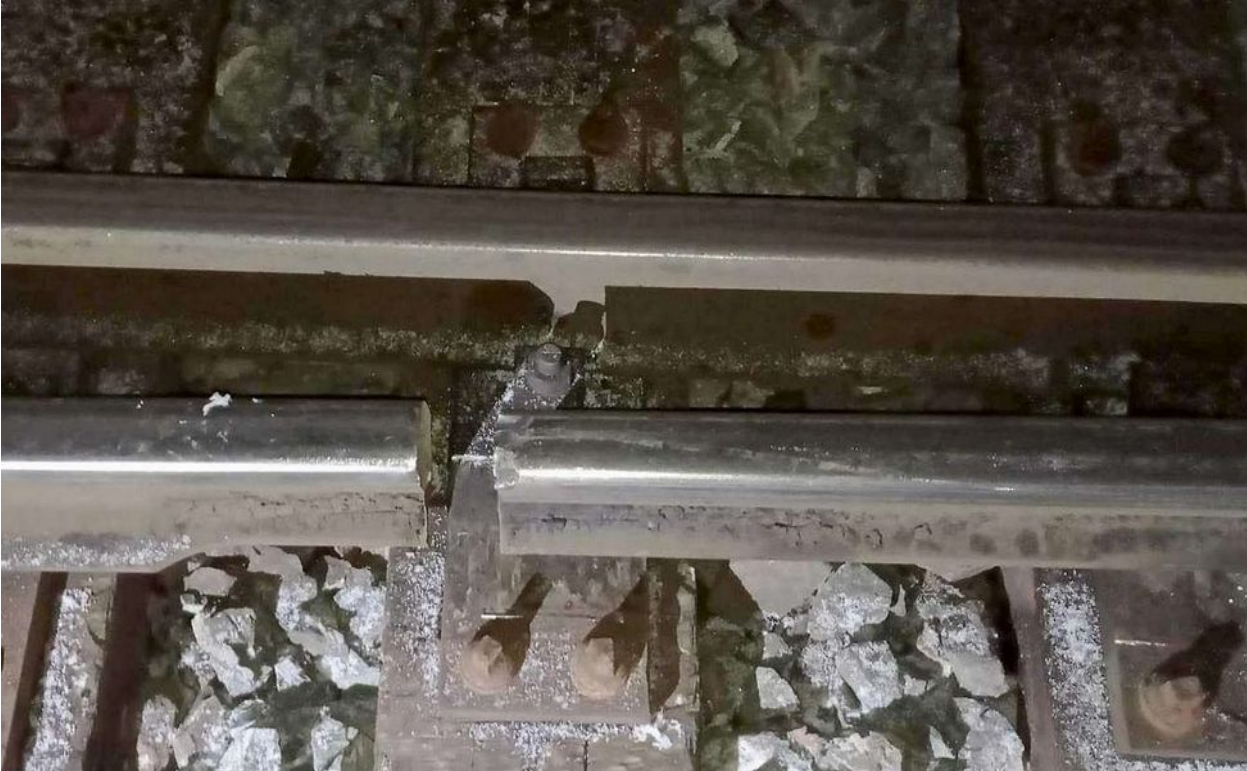
Date and time: 3rd March 2021, 7:18 (6:18 GMT).
Occurrence type: train derailment.
Description: fracture of the point blade of the switch No. 12, derailment, spontaneous re-railing of the regional passenger train No. 4817 and its consequent unsecured movement on another track.
Type of train: the regional passenger train No. 4817.
Location: Náměšť nad Oslavou station, switch No. 12, km 30,045; place of the train derailment was at km 30,044.
Parties: Správa železnic, státní organizace (IM);
České dráhy, a. s. (RU of the regional passenger train No. 4817).
Consequences: 0 fatality, 0 injury;
total damage CZK 120 976,-

2. the regular controls should be implemented in the control activities at the overtaking stations on the running track which are high work loaded and/or running at high speeds. Due to found impact of running clearance of fit of the switch blades on the slide baseplates, catching up of the web of the switch blades to the studs and catching up of the switch blade heads to the stock rail on size of dynamic loading of switch blades, these controls should be focused on clearances mentioned above by the value measurement or by implementation of the regular finding of size of dynamic loading of the blade switches using modern diagnostic methods which fix appropriate limits of these clearances, so that the limit violation of these clearances will be revealed. In the same time, the record of the measuring data will be kept, the found defects will be removed in time and the values of clearances will be constrained.

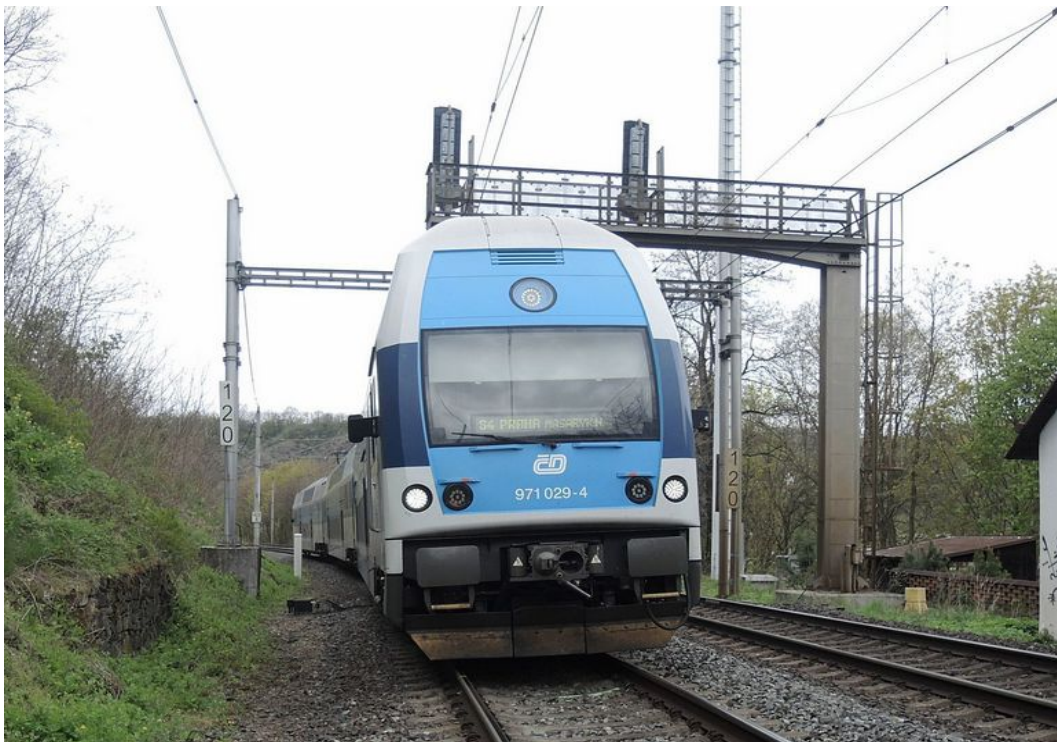
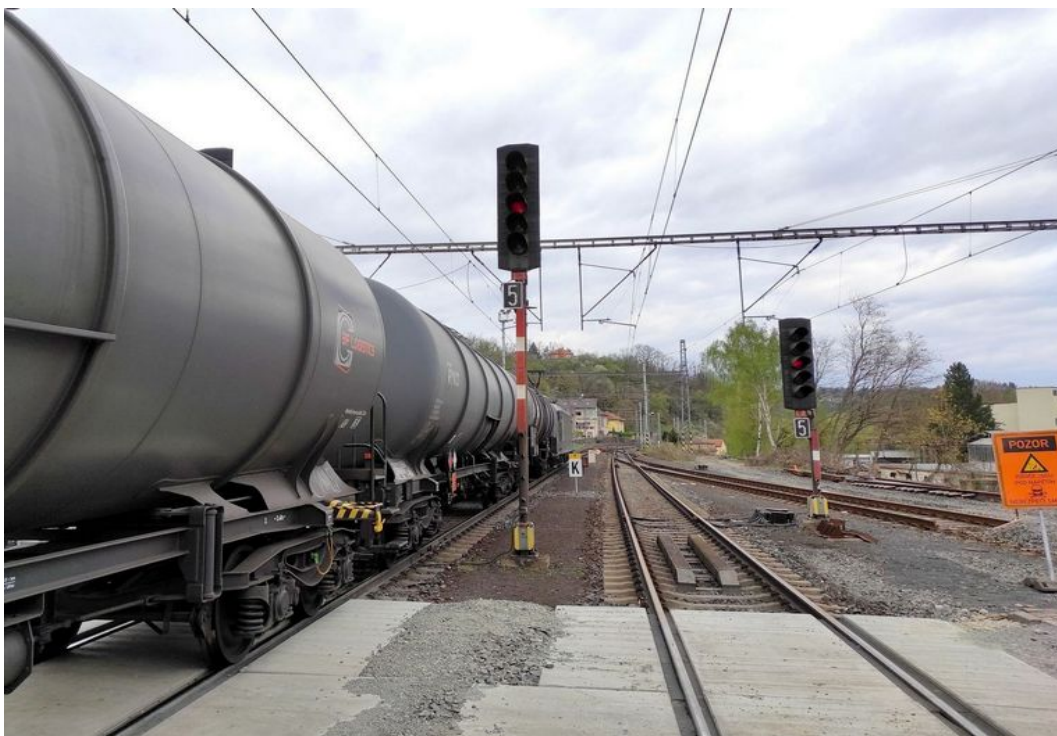
- Date and time: 10th May 2021, 6:12 (4:12 GMT).
- Occurrence type: unauthorized movement.
- Description: unauthorized movement of the regional passenger train No. 9608 behind the main signal device and entry to the train route for the regional passenger train No. 6903.

- to create and implement a system of practical training for train dispatchers, when it will be create crisis situations requiring an appropriate reaction to the immediate threat to the safe operation of railway transport in order to avert an occurrence or reduce their consequences without unnecessary delay.

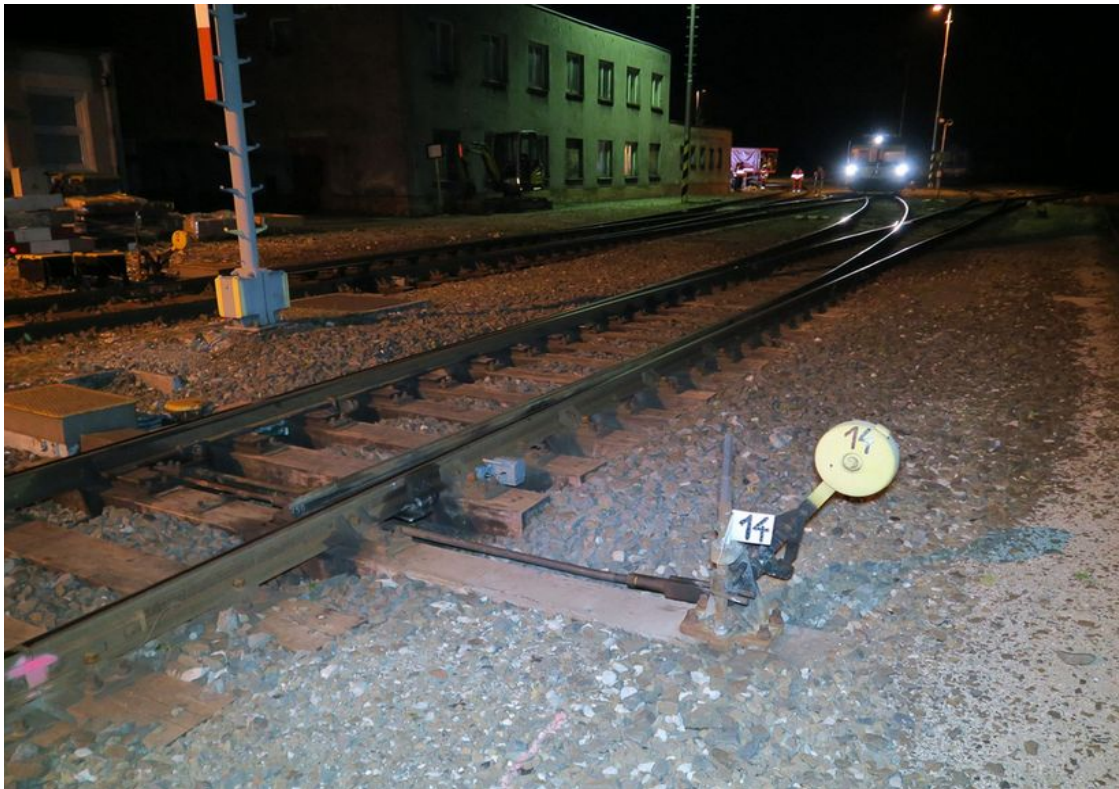
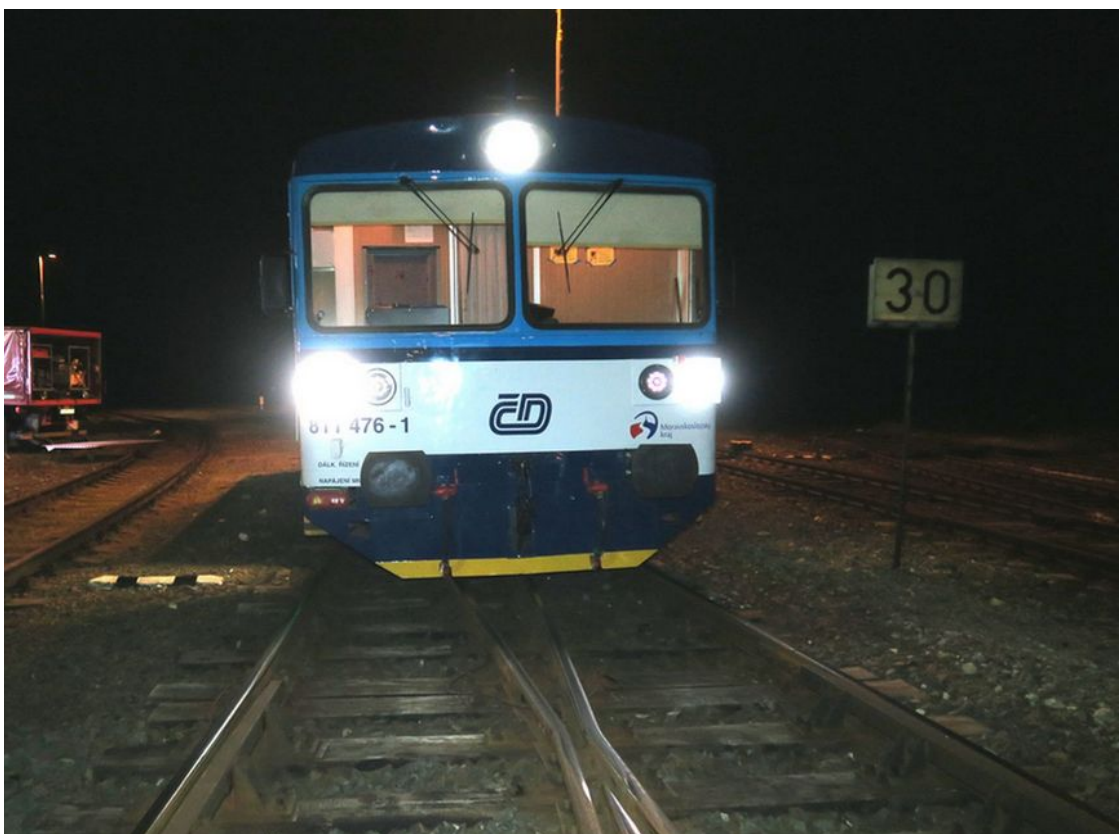
- Date and time: 18th June 2021, 10:10 (8:10 GMT).
- Occurrence type: a train collision.
- Description: an unauthorized movement of the shunting operation behind the signal device Se12 and its consequent collision with the standing regional passenger train No. 9010.

necessary to determinate the rules in case, when it is not possible to drive the locomotive from the driver's footplate where it is the best view ensured (when the driver's footplate of the second locomotive for shunting in the opposite direction is practically unattainable), this should be defined including determination of the speed limit.

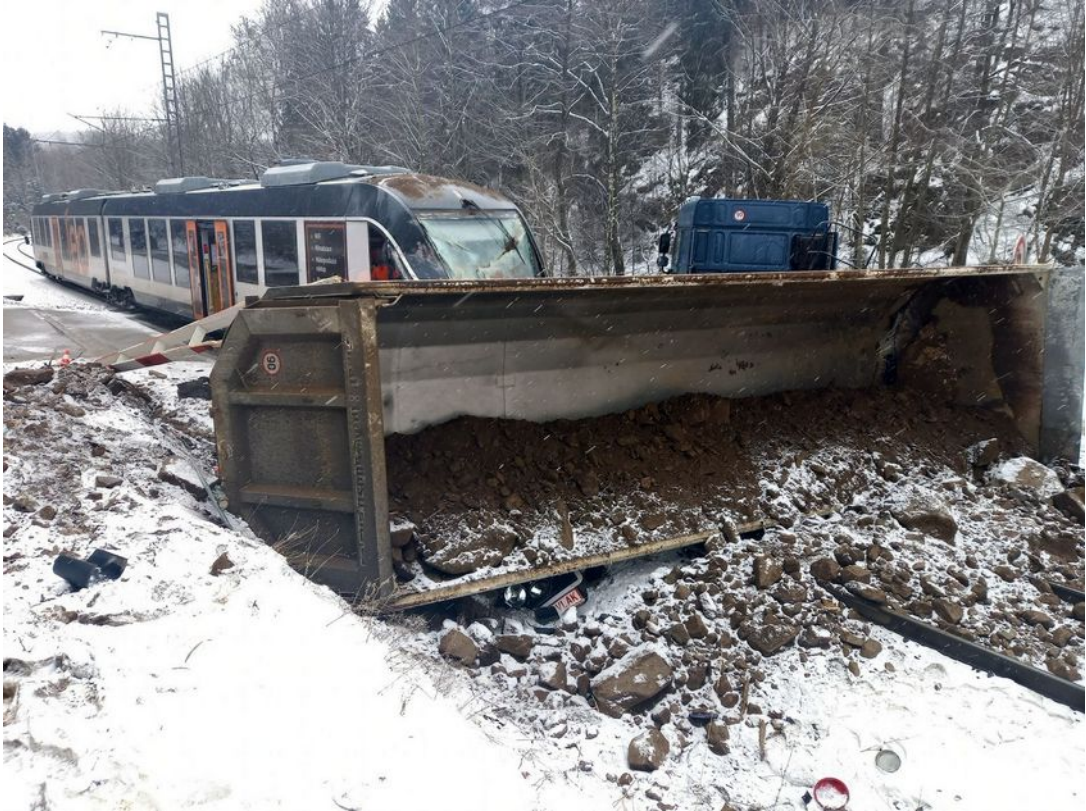
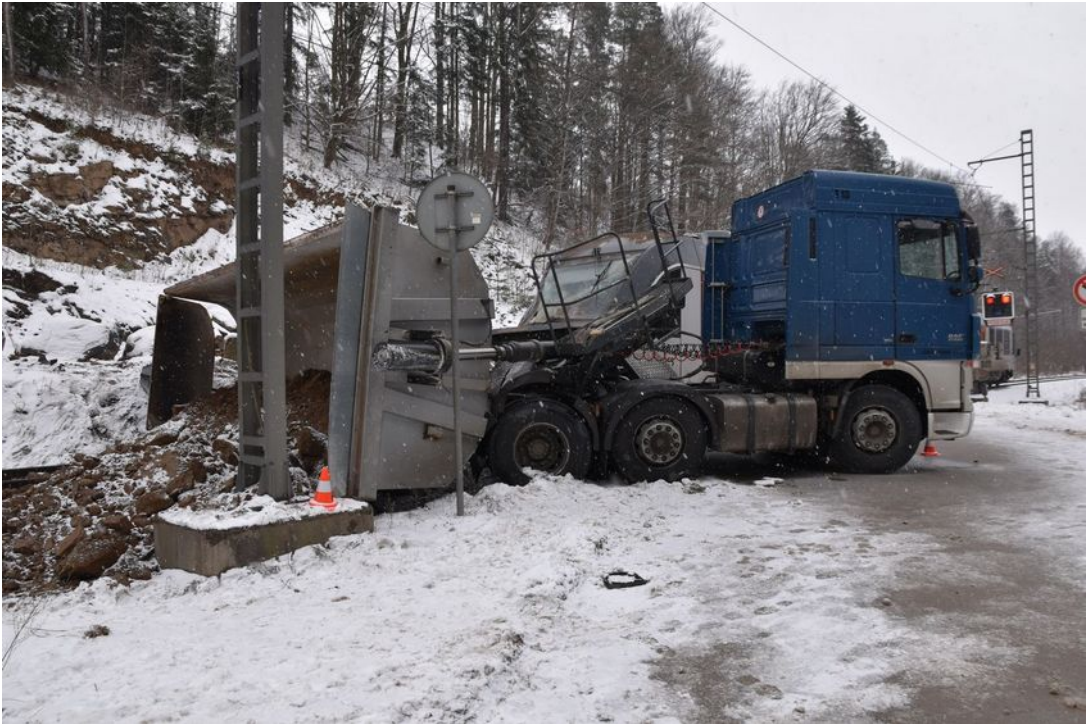
- Date and time: 29th December 2021, 5:45 (4:45 GMT).
- Occurrence type: level crossing accident.
- Description: collision of the regional passenger train No. 14901 with the lorry with consequent derailment.

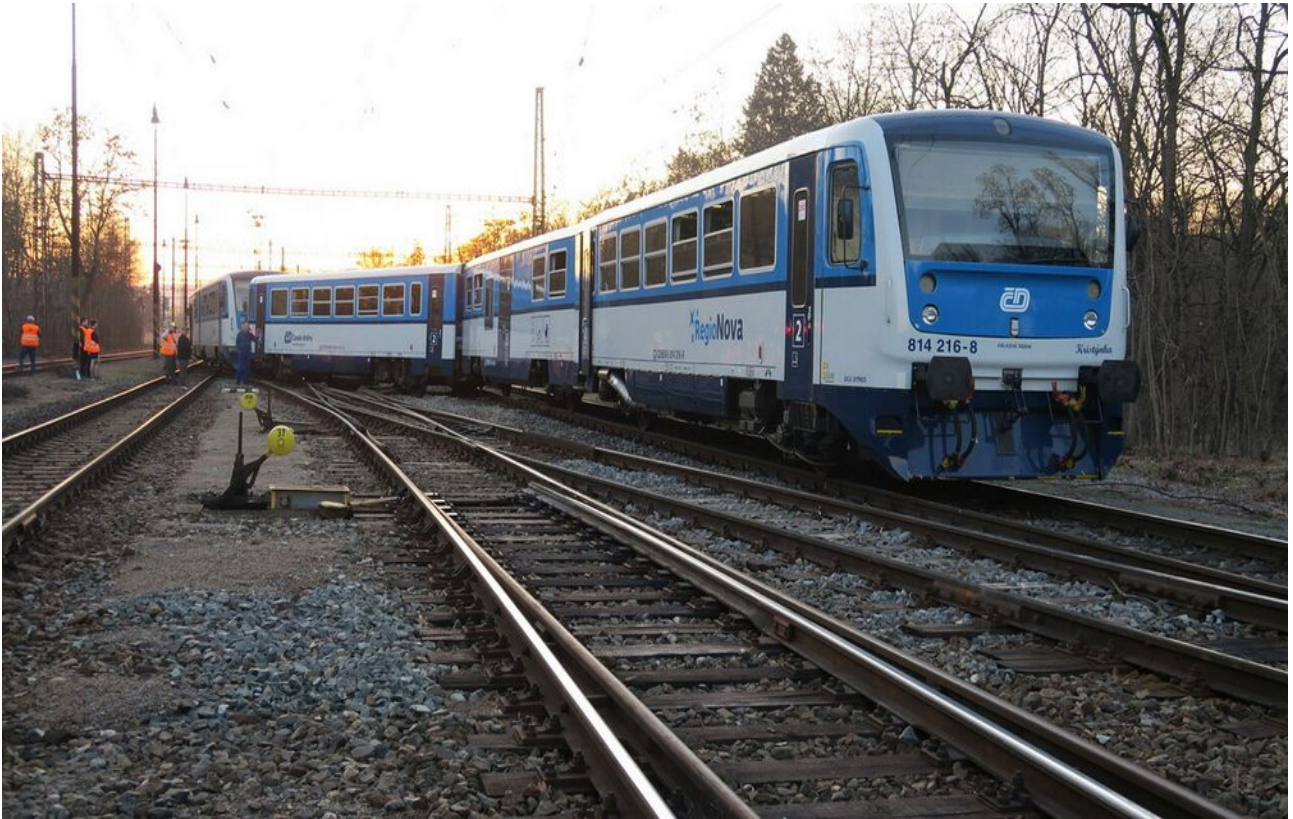
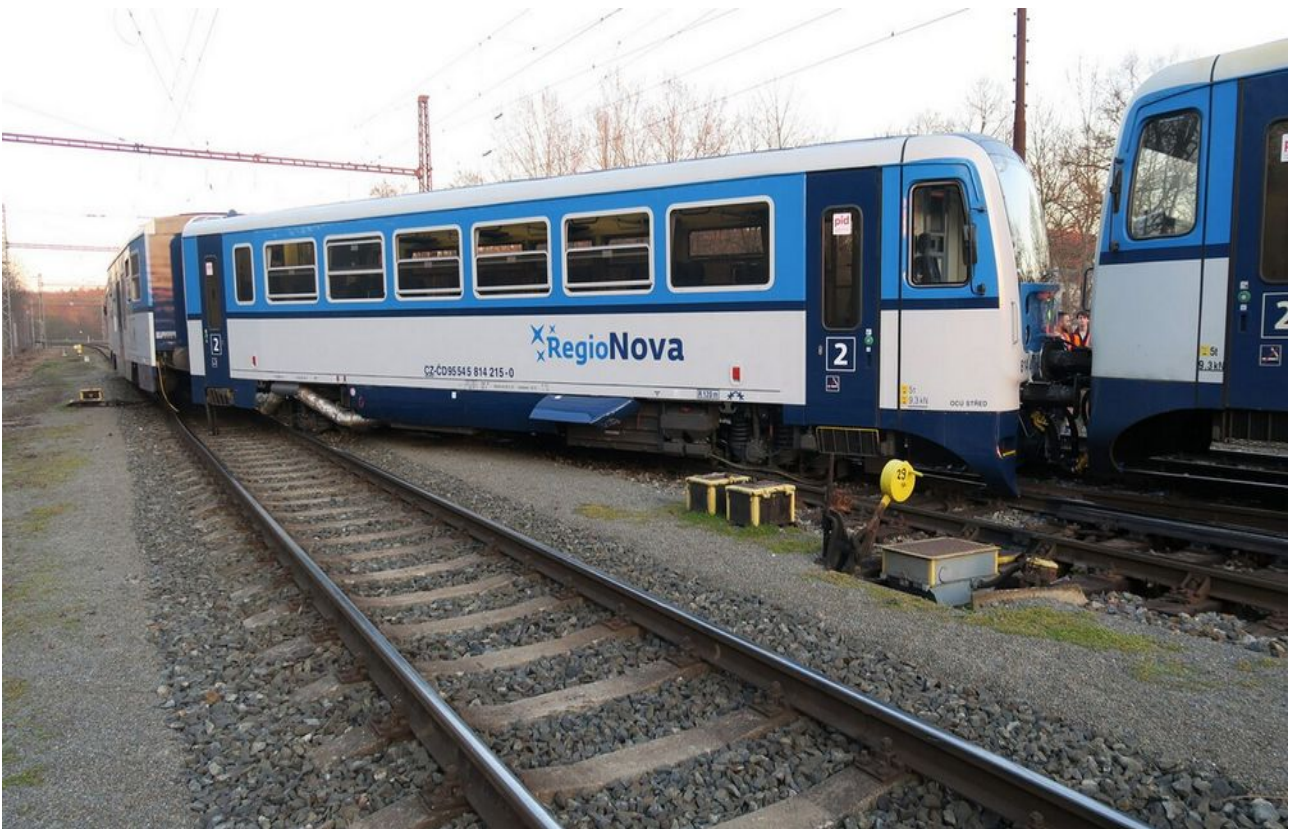
- Date and time: 1st April 2022, 5:56 (3:56 GMT).
- Occurrence type: train derailment.
- Description: unsecured movement of the regional passenger train No. 18000 with consequent derailment.
