The Rail Safety  
Inspection Office

# **NIB ANNUAL REPORT 2014**

according to Article 23(3) of Directive 2004/49/EC

September 2015

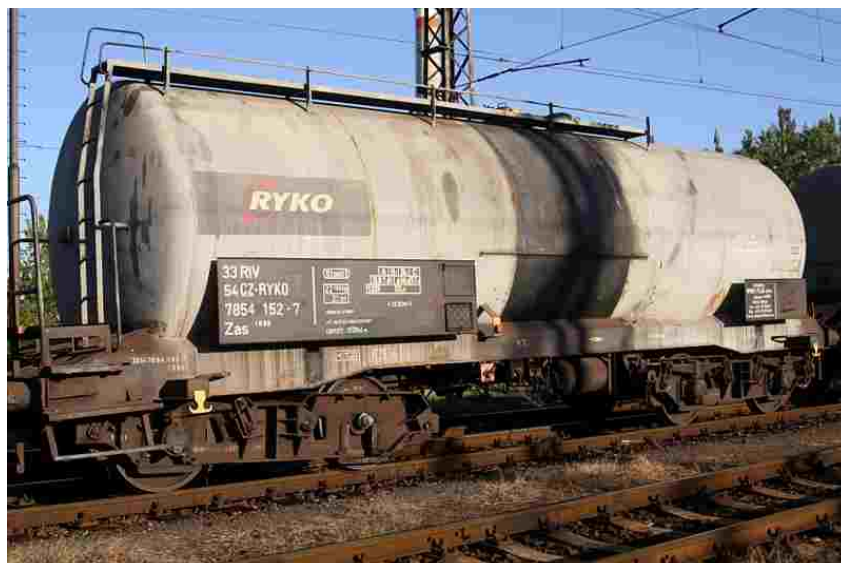
- failure to give the instruction by train dispatchers of Adamov and Brno-Maloměřice stations for an immediate stop of freight train Nex 47763 and for the inspection of the train;

4) Addressed to Czech National Safety Authority (NSA):

- it is recommended to take own measure forcing implementation of the above recommendation for other infrastructure managers (IM) and railway undertakings (RU) in the Czech Republic.

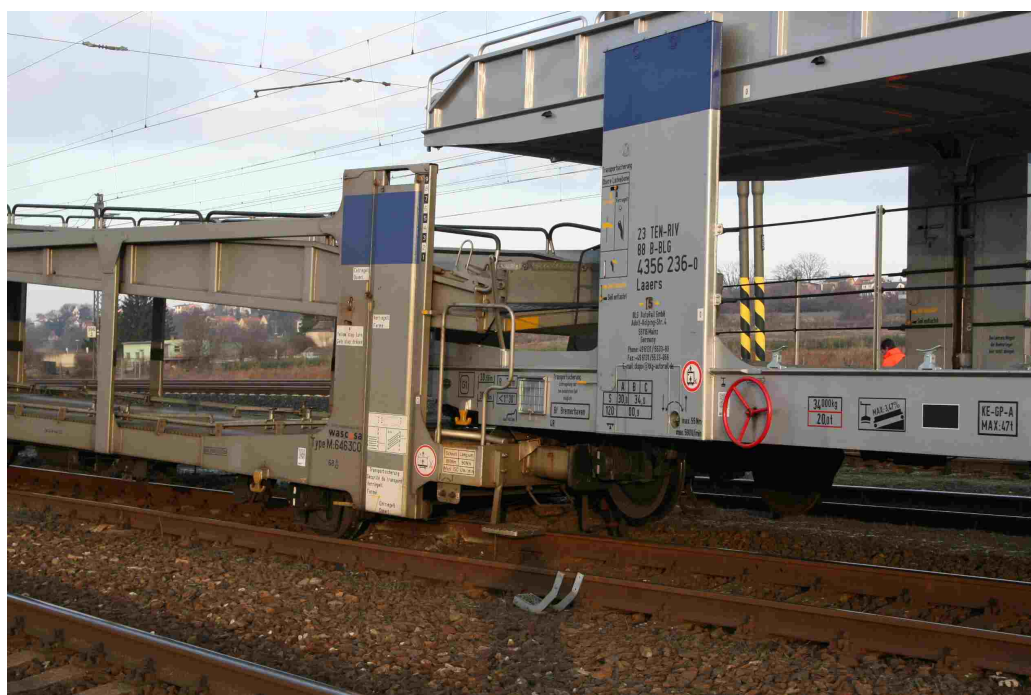
- Contributory factor: none.
- Underlying cause: failure to comply with technological procedures for shunting operation which are set with internal regulations of infrastructure manager and railway undertaking.

- Root cause: none.
- Recommendations: not issued.

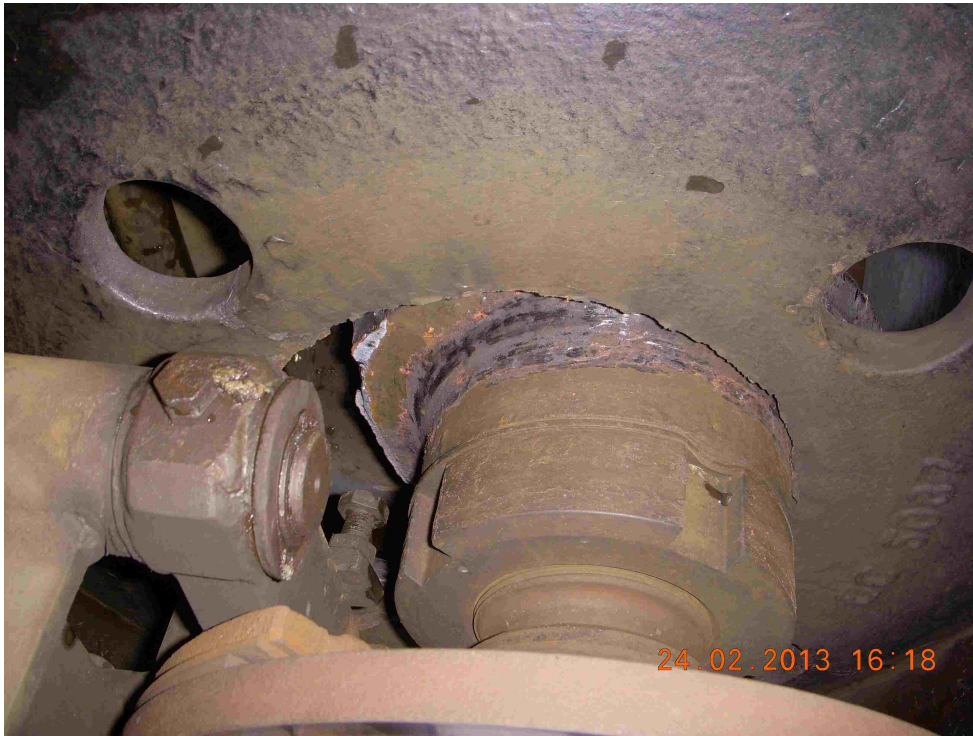
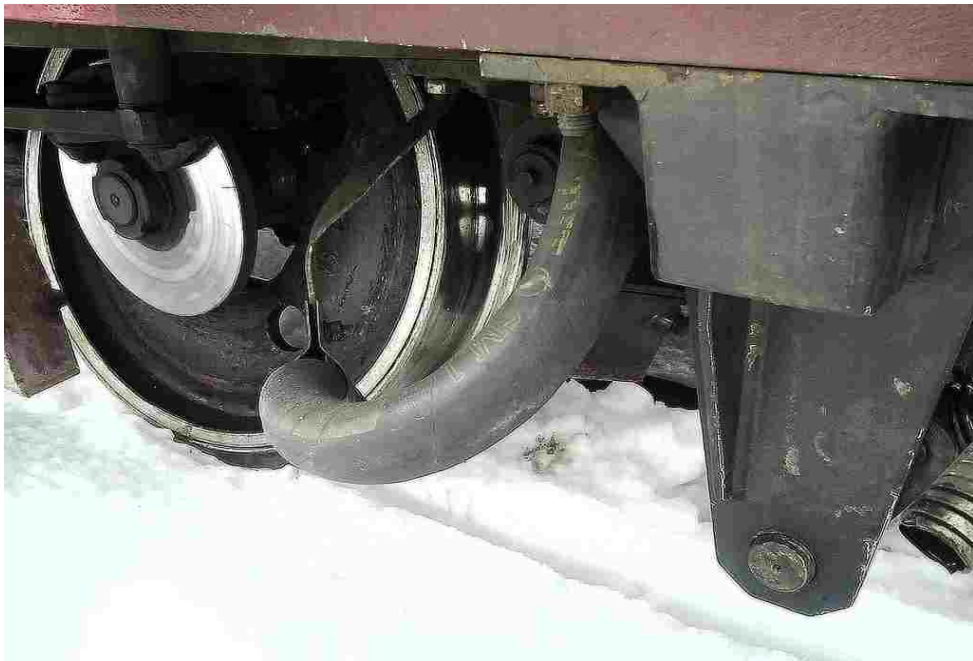
Occurrence type: Broken wheel.

2) Addressed to Czech National Safety Authority (NSA):

- it is recommended to take own measure forcing implementation of the above recommendations for other railway undertaking (RU) in the Czech Republic and to take measure which eliminate approval of changes to rolling socks which are not in accordance with the safety requirements of the railway transport.

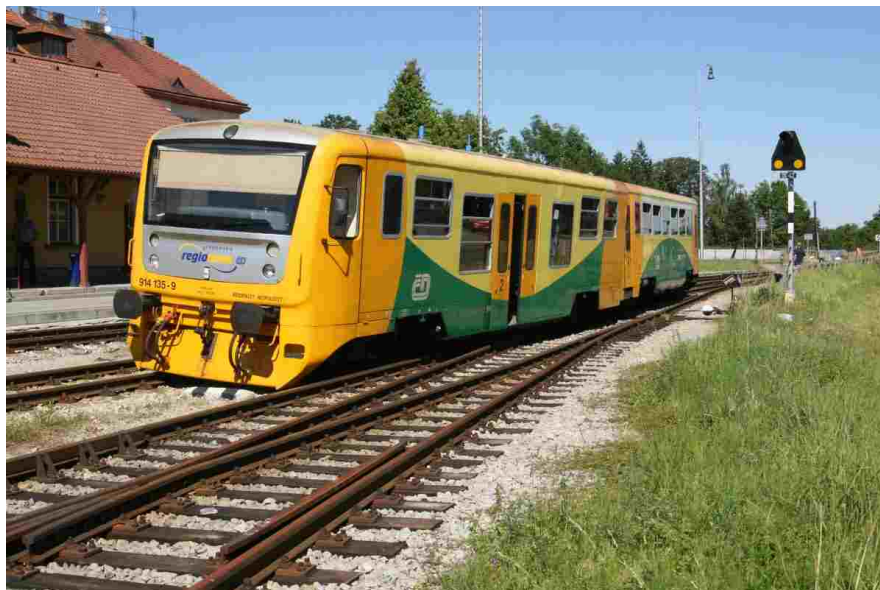
Grade:	accident.
Date and time:	2 <sup>nd</sup> August 2013, 13:56 (11:56 GMT).
Occurrence type:	train derailment.
Description:	Derailment of regional passenger train No. 18008 on self-returning switch No. 2Sv.
Type of train:	regional passenger train No. 18008.
Location:	railway track Čičenice – Volary No. 708 A, Vodňany station, self-returning switch No. 2Sv, km 4,274.
Parties:	SŽDC, s. o. (IM); ČD, a. s. (RU of the regional passenger train No. 18008).
Consequences:	0 fatality, 0 injury; total damage CZK 246 950,-
Direct cause:	the train driver did not respect the instruction of signal Sv2 before entering on self-returning switch No. 2Sv.
Contributory factor:	none.
Underlying cause:	failing to stop of regional passenger train No. 18008 in front of self-returning switch No. 2Sv and failure to control of its correct position at Vodňany station.
Root cause:	none.
Recommendations:	not issued.

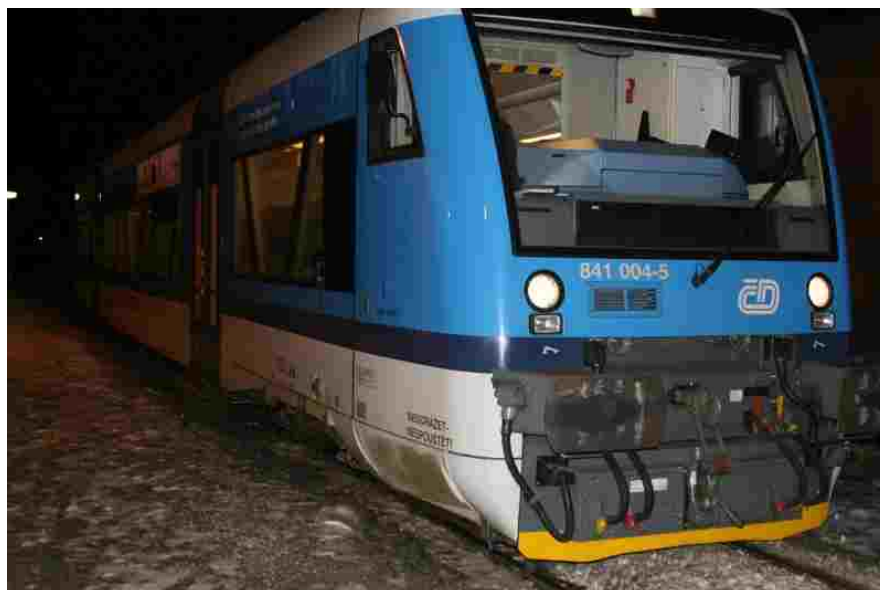
Grade:	incident.
Date and time:	4 <sup>th</sup> February 2014, 14:40 (13:40 GMT).
Occurrence type:	unauthorised train movement other than SPAD.
Description:	departure of regional passenger train No. 15966 from Lípa station without track dispatcher permission to leave station and its movement to occupied track section by freight train No. 82552.
Type of train:	freight train No. 82552; regional passenger train No. 15966.
Location:	Lípa station, station track No. 1, km 7,551.
Parties:	SŽDC, s. o. (IM); ČD, a. s. (RU of the regional passenger train No. 15966 ); ČD Cargo, a. s. (RU of the freight train No. 82552).
Consequences:	0 fatality, 0 injury; total damage CZK 0,-
Direct cause:	departure of regional passenger train from Lípa station without track dispatcher permission to leave station into occupied track section by freight train No. 82552.
Contributory factor:	none.
Underlying cause:	failure to comply with technological procedure (reporting obligation) by engine driver of regional passenger train No. 15966 at Lípa station.

Root cause:	none.
Recommendations:	not issued.

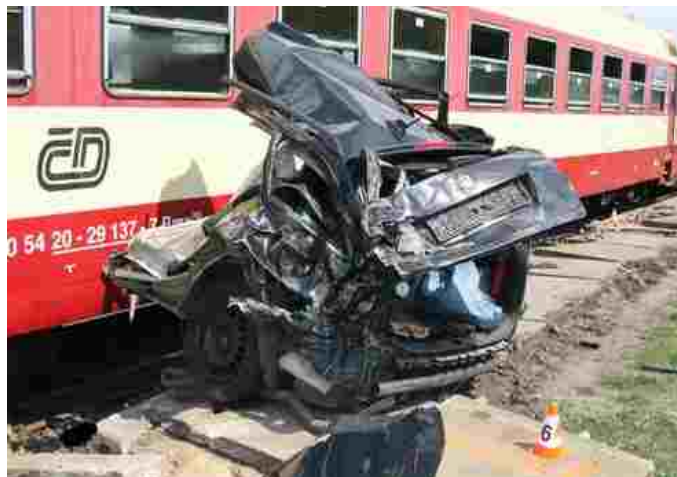
Grade:	accident.
Date and time:	30 <sup>th</sup> April 2014, 12:40 (10:40 GMT).
Occurrence type:	level crossing accident.
Description:	Collision of regional passenger train No. 1725 with an obstacle – a car at the level crossing.
Type of train:	passenger train No. 1725.
Location:	open line between Kyjov and Vlkůš stations, level crossing No. 7935 near the Kyjov train stop, km 64,247.
Parties:	ČD, a. s. (RU of the passenger train No. 1725); Správa železniční dopravní cesty, s. o. (IM); driver of the car (level crossing user).
Consequences:	1 fatality (car driver); total damage CZK 488 233,-
Direct cause:	<ul style="list-style-type: none"><li>• third party – level crossing user (car driver's violation);</li><li>• failure to comply with measures for train caution train Sp 1725.</li></ul>
Contributory factor:	none.
Underlying cause:	<ul style="list-style-type: none"><li>• car driver behaviour before the level crossing, in the distance of visibility warning crosses for safe stop where it is necessary to behave particularly carefully and make sure it is possible safely cross over the level crossing;</li><li>• not giving priority to rail traffic at level crossings with road track;</li><li>• human error, which resulted in a failure to oversights and observe the signal "open level crossing" and disregard for the universal order for the train No. 1725 by the train driver.</li></ul>

Root cause:	none.
Recommendations:	not issued.
