# **NIB ANNUAL REPORT 2021**

according to Article 24(3) of Directive (EU) 2016/798

The Rail Safety Inspection Office

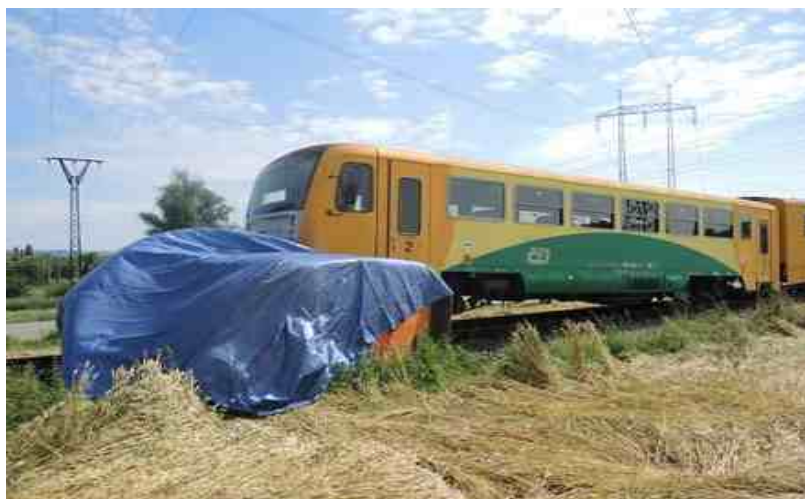
Date and time:	15 <sup>th</sup> July 2020, 19:15 (17:15 GMT).
Occurrence type:	train derailment.
Description:	derailment of the regional passenger train No. 5338 at the entrance to the Medlešice station.
Type of train:	the regional passenger train No. 5338.
Location:	Medlešice station, switch No. 1, km 83,494.
Parties:	Správa železnic, státní organizace (IM); České dráhy, a. s. (RU of the regional passenger train No. 5338).
Consequences:	0 fatality, 0 injury; total damage CZK 587 000,-
Causal factor:	<ul style="list-style-type: none"><li>• unauthorized change of position of the switch No. 1 at the time, when the rolling stocks of the train No. 5338 were on the switch, which was preceded by a failure to detect whether the train No. 5338 has arrived whole at the designated track and premature cancellation of train route for this train.</li></ul>
Contributing factor:	<ul style="list-style-type: none"><li>• time pressure which was not properly eliminated by the station dispatcher due to insufficient vigilance and awareness of risk.</li></ul>

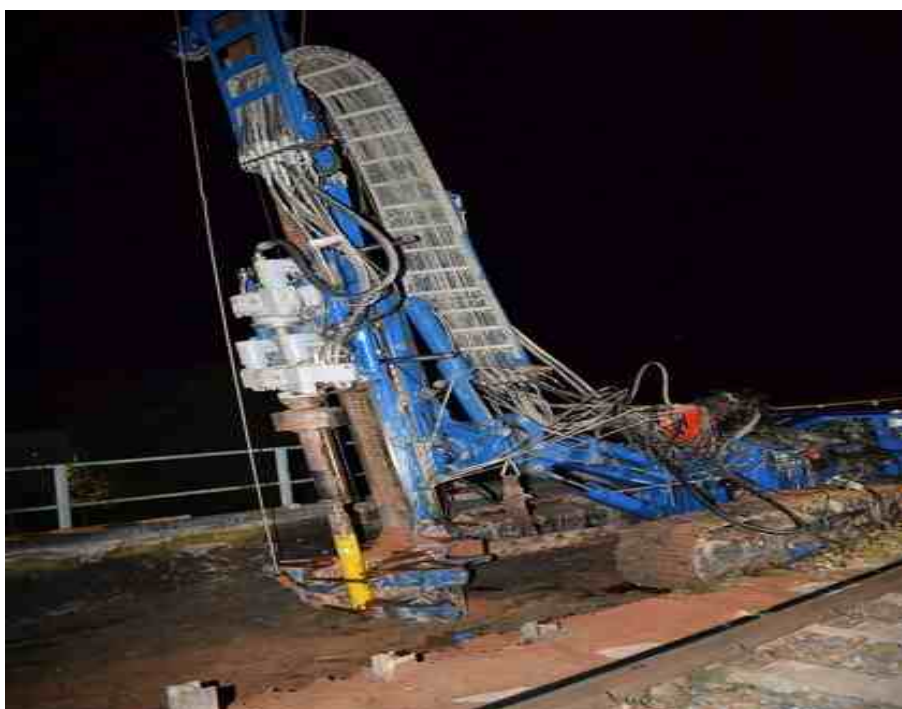
Date and time:	31 <sup>st</sup> August 2020, 11:19 (9:19 GMT).
Occurrence type:	an accident to a person caused by a rolling stock in motion.
Description:	collision of the regional passenger train No. 1716 with the external worker in the open line track.
Type of train:	the regional passenger train No. 1716.
Location:	open line track between Balkova Lhota and Božejovice stations, km 12,462.
Parties:	Správa železnic, státní organizace (the IM); České dráhy, a. s. (the RU of the regional passenger train No. 1716); the external worker.
Consequences:	1 fatality; total damage CZK 0,-
Causal factor:	<ul style="list-style-type: none"><li>• unauthorized entrance of the external worker into the structure gauge of the open line track while the train No. 1716 was moving.</li></ul>
Contributing factor:	none.
Systemic factor:	none.
Recommendation:	not issued.

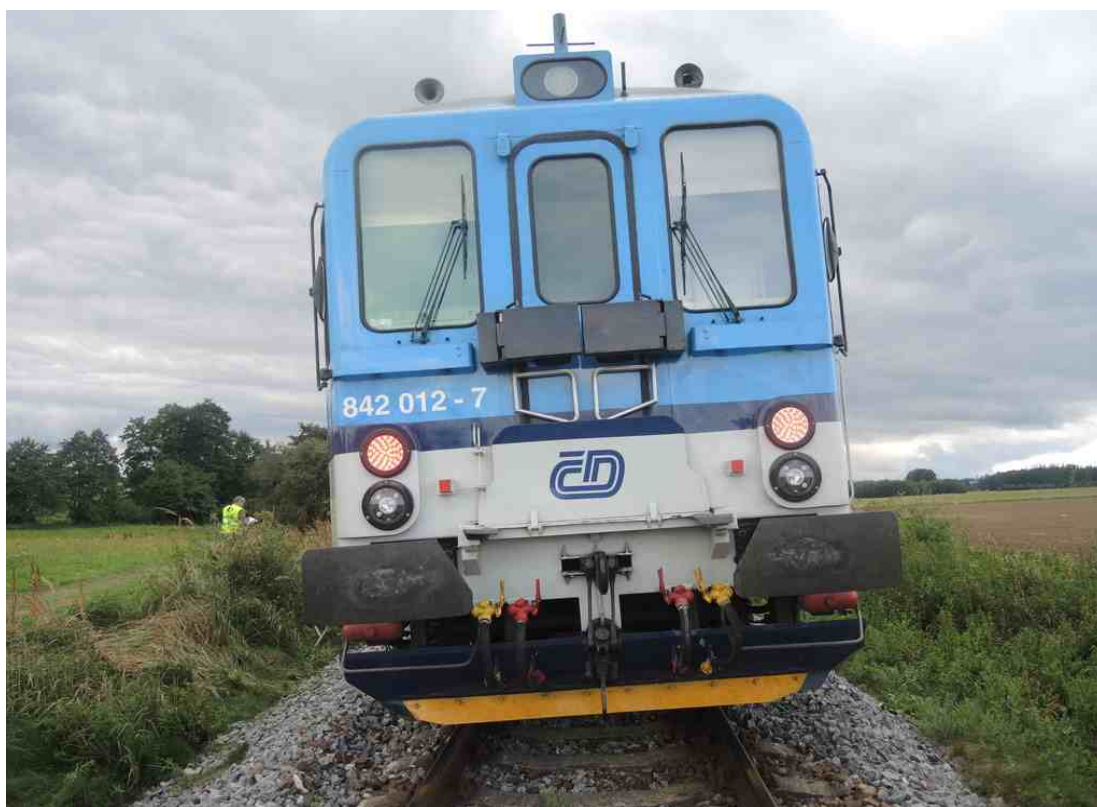
Date and time:	2 <sup>nd</sup> September 2020, 8:08 (6:08 GMT).
Occurrence type:	level crossing accident.
Description:	collision of the regional passenger train No. 11414 with a car at the level crossing No. P3949.
Type of train:	the regional passenger train No. 11414.
Location:	open line between Moravské Bránice and Ivančice stations, the level crossing No. P3949, km 3,127.
Parties:	Správa železnic, státní organizace (the IM); České dráhy, a. s. (the RU of the regional passenger train No. 11414); driver of the car (level crossing user).
Consequences:	1 fatality; total damage CZK 68 936,-
Causal factor:	<ul style="list-style-type: none"><li>• an unauthorized entrance of the car at the level crossing No. P3949 at the time when the train No. 11414 was arriving, caused by behavior of the car driver, who did not respect the traffic sign „Stop, give a priority!” and did not stop the car at a place where she would have a proper view of the track and did not make sure whether she could safely pass the level crossing.</li></ul>
